CRREL REPORT

95-24

Ground-Penetrating Radar Investigation of the Proposed Dome- CARA Tunnel Route and Utilities at South Pole Station, Antarctica

December 1995

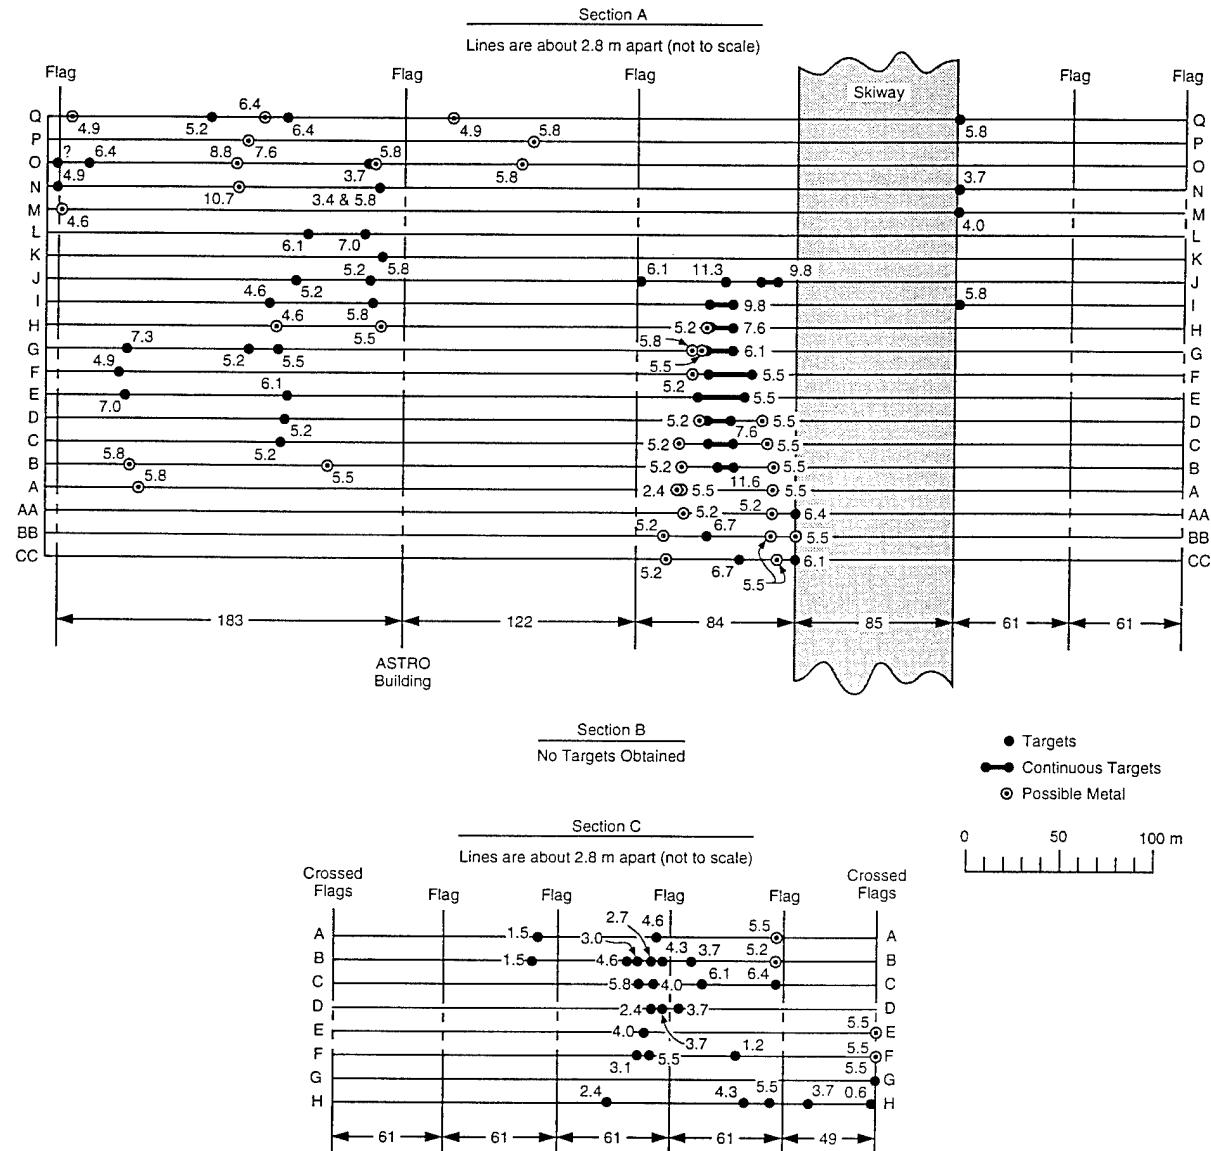
Scattered debris west of the ASTRO building is located at depths that will cause it to interfere with tunneling. However, safe routes through this area are possible. Our route surveys enabled us to find debris and assess the suitability of tunneling routes, but that work was not conducted to pinpoint the location of each potential problem. An additional radar survey for that purpose will be needed just prior to tunneling.

Figure 21. Plan view of the primary tunnel survey. Dots represent radar targets and circled dots are the more intense echoes that are probably from metal targets. Faint reflections may also be metallic targets but with a very small radar cross section. Bars (west of the runway) represent a dense continuum of targets. Numbers beside the dots and bars are depths to the targets in meters. Average line spacing is 2.8 m (not drawn to scale for clarity).

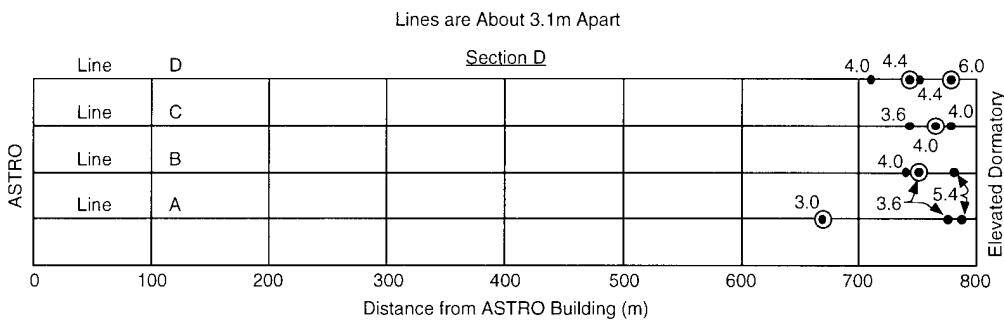
Figure 22. Plan view of the survey run between the ASTRO building and the elevated dormitory. Survey lines begin at the edge of the ASTRO building and terminate at approximately 800 m, about 10 m short of the base of the dormitory. Average survey line spacing is in meters. Dots indicate radar targets with depths in meters indicated.

mately 800 m. This swath appears to be clear of any subsurface debris, except very near the dormitory. Surveys performed at several utility sites near the main station provided a general assessment of the dielectric properties of the firn, and tested the radar's ability to delineate subsurface features and potential hazards. Migrated, spatial images of the old clean air facility, the water well under development, and the several sewage sumps are presented. In general, the numerous vents, cables, antennas, etc., of the area clutter the profiles with diffractions that complicate interpretation of the data without prior knowledge of some features. The migrated images allowed approximations to be made as to the depths of sewage sumps, the water well and the old buried clean air facility.
